# LEAKING FLANGE COUPLINGS SEALED WITH BELZONA

ID: 6331

Flange couplings at a paper press machine

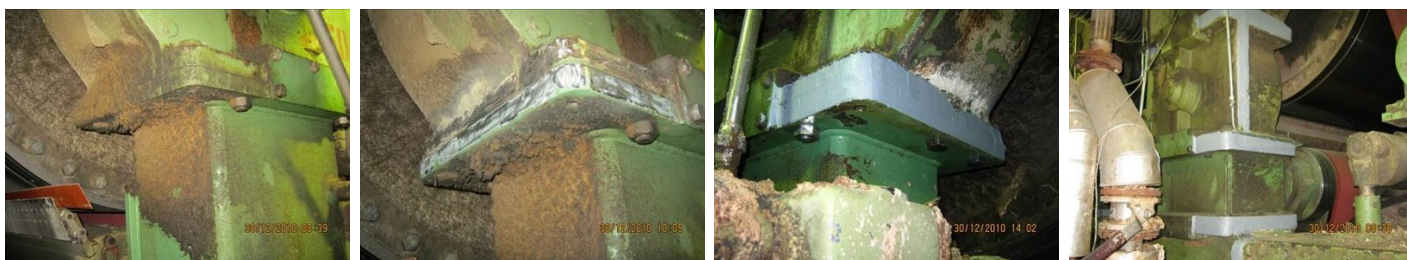
*After several years in operation and due to vibration, oil started to leak from some couplings leading to pollution and loss of efficiency.*

\* 1. Leaking flange coupling 2. Surface preparation 3. Belzona repair 4. Belzona repair ,

The application was carried out in accordance with Belzona Know-How System Leaflet TCC-1 for sealing cracks, porous welds, bolted and riveted joints. The surface was cleaned with Acetone and abraded using the MBX bristle blaster. Belzona 1161 was applied in conjunction with Belzona 9341 to seal the leak.
