# BELZONA PROTECTS MAIN ENTRY OF APARTMENT

ID: 6332

Main entry of apartment

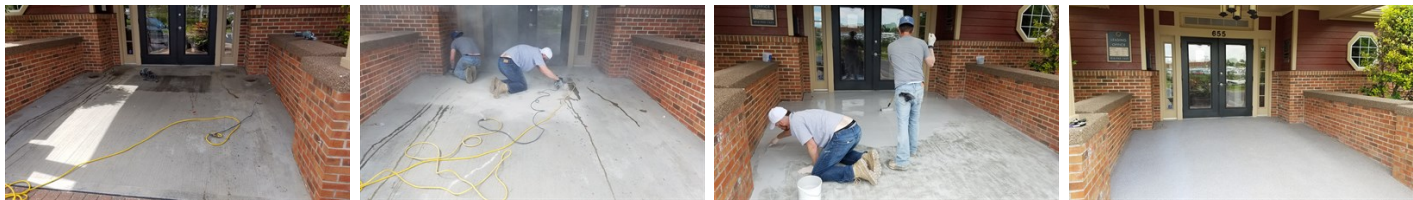
\* 1. The original appearance of the entry with the planters and floor mats removed 2. Diamond grinding under way 3. Application of Belzona 5231 4. Completed application of 5231/locally sourced aggregate/5233 ,

The concrete was prepared via diamond grinding and vacuuming, followed by the application of Belzona 5231 broadcasted with excess of custom blended color flake. A top coat of Belzona 5233 clear for sealing. A modified FPA-8 system leaflet was followed.
