BELZONA PROTECTS INTERNAL OF CHP STACK

ID: 6335

Customer Location: *Papermill, Scotland, UK*
Application Date: *May 2016*

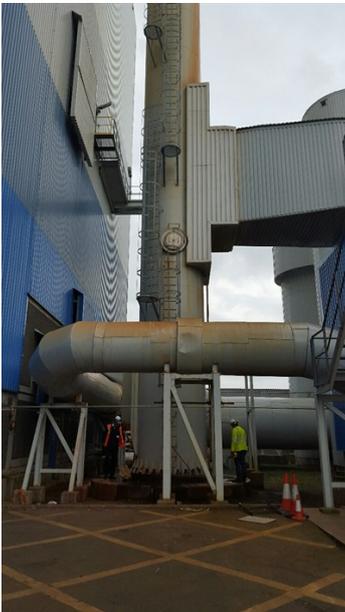
- * 1. CHP Stack ,
- * 2. Plates welded in place during previous attempted repairs ,
- * 3. Base of the stack coated ,
- * 4. completed Belzona 1593 coating ,

The stack of the plants CHP (Combined Heat & Power) unit

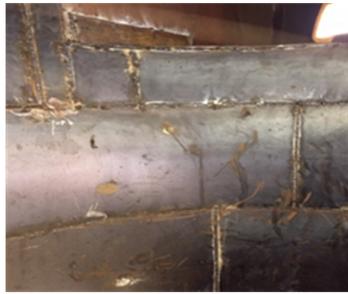
The stack had been experiencing corrosion issues from the chemicals within the flue gas stream. It was suspected that acids within this stream were condensing on the vertical wall of the stack & causing excessive corrosion around the localized area. Repairs had been attempted in the past by welding mild steel plates to the internals of the stack during shutdowns. This did not solve the problem & the base issue kept occurring year after year.
