BELZONA PROTECTS INTERNAL OF CHP STACK

ID: 6335

Industry: *Pulp & Paper*
Application: *TCC-Tanks and Chemical Containment Areas*
Substrate: *Mild Steel*
Products: ** Belzona 1593 ,*

Customer Location: *Papermill, Scotland, UK*
Application Date: *May 2016*

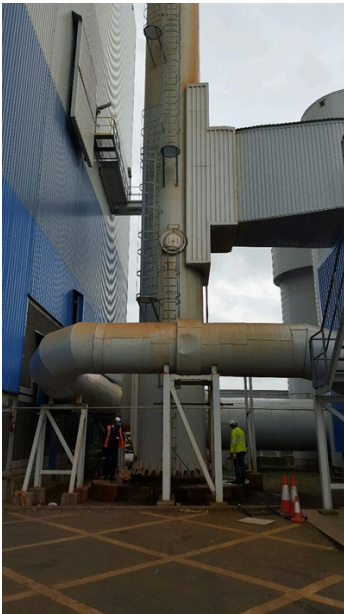
- * 1. CHP Stack ,
- * 2. Plates welded in place during previous attempted repairs ,
- * 3. Base of the stack coated ,
- * 4. completed Belzona 1593 coating ,

The stack of the plants CHP (Combined Heat & Power) unit

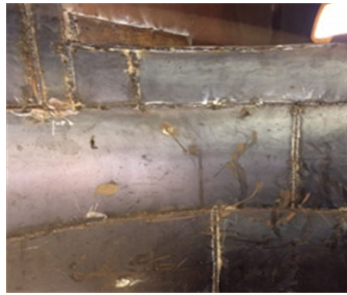
The stack had been experiencing corrosion issues from the chemicals within the flue gas stream. It was suspected that acids within this stream were condensing on the vertical wall of the stack & causing excessive corrosion around the localized area. Repairs had been attempted in the past by welding mild steel plates to the internals of the stack during shutdowns. This did not solve the problem & the base issue kept occurring year after year.
