BELZONA PROTECTS INTERNAL OF CHP STACK

ID: 6335

Customer Location: Papermill, Scotland, UK
Application Date: May 2016

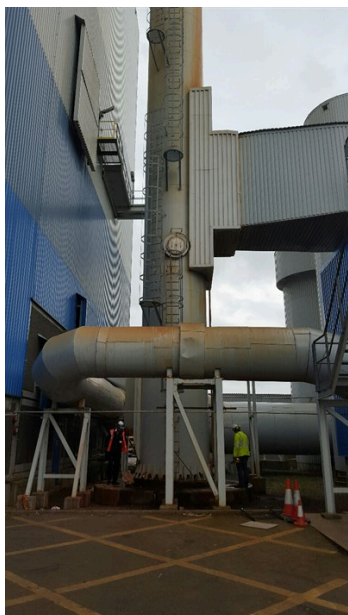
- * 1. CHP Stack ,
- * 2. Plates welded in place during previous attempted repairs ,
- * 3. Base of the stack coated ,
- * 4. completed Belzona 1593 coating ,

The stack of the plants CHP (Combined Heat & Power) unit

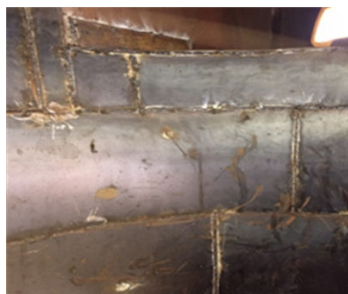
The stack had been experiencing corrosion issues from the chemicals within the flue gas stream. It was suspected that acids within this stream were condensing on the vertical wall of the stack & causing excessive corrosion around the localized area. Repairs had been attempted in the past by welding mild steel plates to the internals of the stack during shutdowns. This did not solve the problem & the base issue kept occurring year after year.
