BELZONA PROTECTS HAZARDS DRAIN TANK

Industry: Oil & Gas
Application: TCC-Tanks and Chemical Containment Areas
Substrate: Carbon Steel
Products: * Belzona 1391S ,
* Belzona 1391T ,

Customer Location: Offshore platform, UK North Sea
Application Date: August 2016

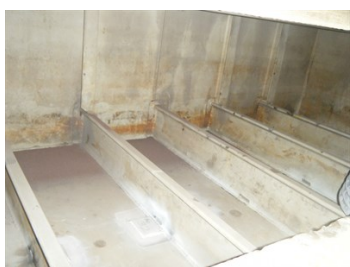
Once opened and inspected it was decided to replace the lower 1 meter of the existing coating before putting the tank back into service. MIC (microbiologically induced corrosion) was affecting the bottom of the tank and causing local pitting of the steel.

* 1. Original coating 2. Grit blasting underway 3. Inspection of 1st Coat 4. Completed application with 2nd coat applied. ,
