# BELZONA PROTECTS HAZARDS DRAIN TANK

ID: 6337

Customer Location: Offshore platform, UK North Sea  
Application Date: August 2016

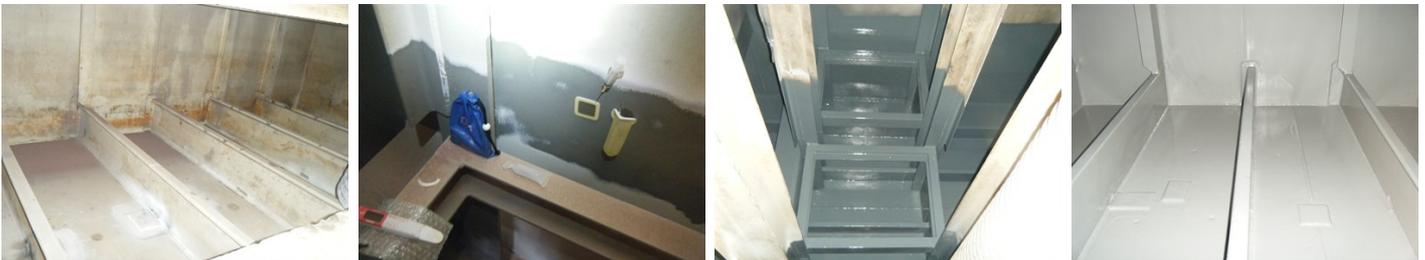
Once opened and inspected it was decided to replace the lower 1 meter of the existing coating before putting the tank back into service. MIC (microbiologically induced corrosion) was affecting the bottom of the tank and causing local pitting of the steel.

\* 1. Original coating 2. Grit blasting underway 3. Inspection of 1st Coat 4. Completed application with 2nd coat applied. ,

A hazards drains tank found to be suffering metal loss when UT inspected.

Application was carried out in accordance with Belzona System Leaflets TCC-3 and TCC-5. after rebuilding deep pits with Belzona paste grade rebuilding product, Belzona 1391S was applied using heated airless spray with Belzona 1391T applied by brush as a stripe coat.
