Belzona Repair on Concrete Dam

ID: 6343

Customer Location: Michigan, USA
Application Date: September 2016

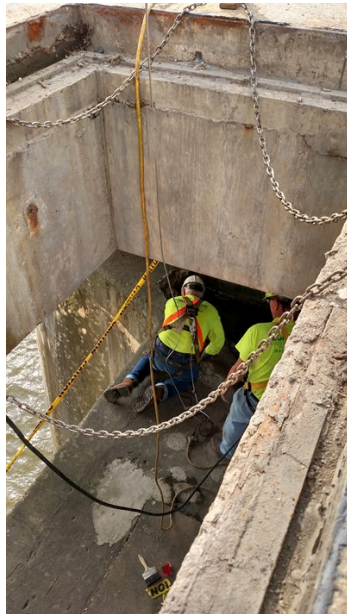
The damaged area is partially submerged and the entire area frequently wet from wave action. The dam has been declared a historic site so repair materials need to closely match the appearance of the original material.

- * 1. Damaged area at waterline ,
- * 2. Work in process. ,
- * 3. Finished repair ,

The face of the 100 yr old concrete hydro dam was damaged at the waterline due to ice and wave action.

A temporary dyke was created around the area needing repair. Compressed air was used to blow the standing water off the

damaged area. The surface was prepped with chisels and a bristle blaster. Dust and loose debris were blown off. The 4911 was applied and the repair was made with 4141 to just below the desired finish level. Finally a coat of 4131 was applied to finish the work .
