Belzona Repair on Concrete Dam

ID: 6343

Customer Location: Michigan, USA
Application Date: September 2016

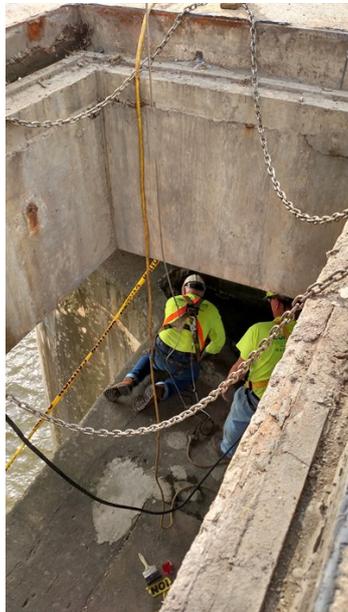
- * 1. Damaged area at waterline ,
- * 2. Work in process. ,
- * 3. Finished repair ,

The face of the 100 yr old concrete hydro dam was damaged at the waterline due to ice and wave action.

A temporary dyke was created around the area needing repair. Compressed air was used to blow the standing water off the

damaged area. The surface was prepped with chisels and a bristle blaster. Dust and loose debris were blown off. The 4911 was applied and the repair was made with 4141 to just below the desired finish level. Finally a coat of 4131 was applied to finish the work .
