# BELZONA REPAIRS AND COATS END SUCTION PUMP CASING

ID: 6344

Industry: *Pulp & Paper*  
Application: *CEP-Centrifugal Pumps*  
Substrate: *Carbon Steel*  
Products: *\* Belzona 1121 (Super XL-Metal) ,*  
*\* Belzona 5821 ,*

Customer Location: *Campti, Louisiana*  
Application Date: *June 2016*

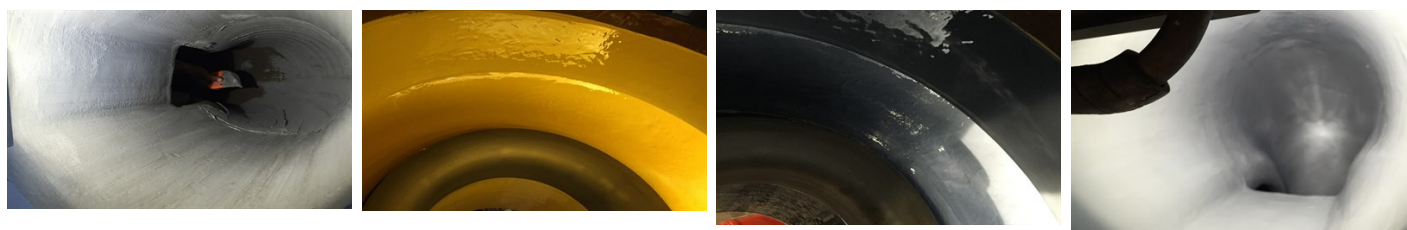
## Photograph Descriptions

*The casing was badly damaged and cracked*

\* 1. Installing Belzona 1121 to fill pits and form smooth uniform surface 2. First coat of Belzona 5821 applied at 10 mils 3. Second coat of Belzona 5821 being applied at 10 mils 4. Two coats of Belzona 5821, total DFT of 20 mils ,

Surface was abrasive blast to a cleanliness standard of SSPC-SP10 and a minimum of a 3 mil angular profile on internal wet area. Internal pitting and repair damage was filled with Belzona 1121. Two (2) coats of Belzona 5821 was applied at a minimum of 10 mils per coat on internal surfaces. Coated components were inspected and any holidays or imperfection was corrected. Application carried in accordance to system leaflets CEP-3 and CEP-5.
