BELZONA TROUGH REPAIR

ID: 635

Application: *TCC-Tanks and Chemical Containment
Areas*

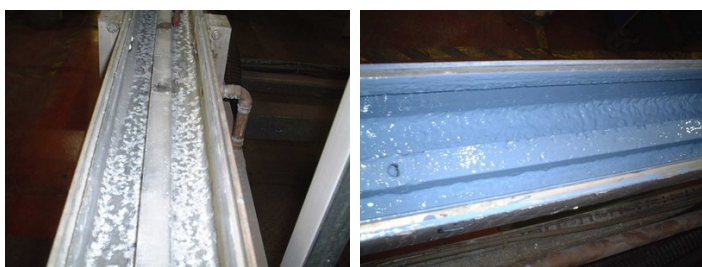
Photograph Descriptions

Micro-biological fouling occurring in trough due to temperature and pitting of substrate caused by chemicals used. This was causing health and safety issues and also leaks at joints.

- * The problem ,
- * The solution ,

Application was carried out in accordance with Belzona Know-How System Leaflet TCC-5.

Belzona gave a cost effective solution to the problem with the only other alternative being to replace all 320 meters (1050ft) of troughs. System still performing well 3 years on.
