# BELZONA SEALS WIND FARM TRANSFORMER

ID: 6351

Industry: Power  
Application: TCC-Tanks and Chemical Containment Areas  
Substrate: Carbon steel  
Products: Belzona 1212,

Customer Location: Wind farm, North Wales  
Application Date: January 2016

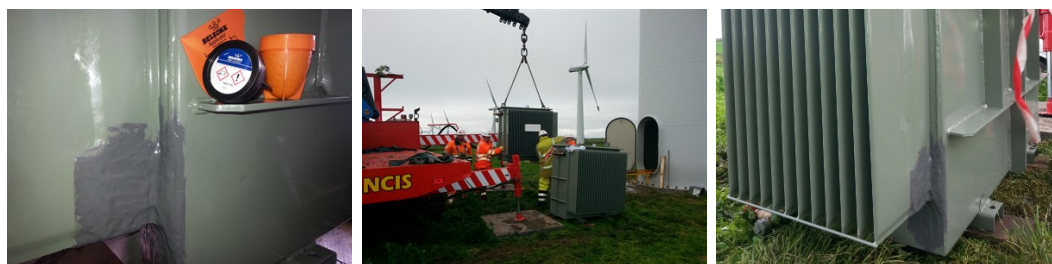
The transformer was leaking transformer oil. This was a safety concern as the transformer could overheat. The transformer could not be transported from site as the leaking oil could contaminate the surrounding farmland. A quick solution was required to avoid operational delays.

Wind turbine oil filled transformer due for replacement.

The application was carried out in accordance with Belzona KnowHow System Leaflet TCC-1. The surface was prepared using power and hand tools before applying the Belzona 1212 to seal the leak.
