# BELZONA ABRASION RESISTANT LINING FOR DE-BARKER

Industry: Pulp & Paper

Application: SHM-Solids Handling Machinery

Customer Location: Paper mill, Poland

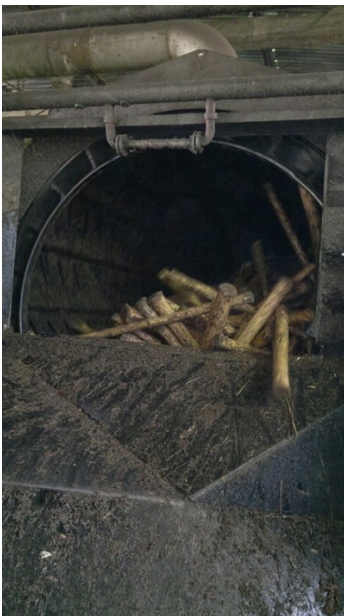
The steel protection plates were wearing away due to severe abrasion. They required a solution to prolong the life of the equipment. If the problem was not resolved during the planned maintenance period, then the customer risked a unscheduled stoppage to the plant and costly downtime.

\* 1. De-barkers create a very abrasive environment 2. Surface preparation prior to application 3. Layers of Belzona 1321 and 1811 applied 4. Belzona 1811 lining of de-barker ,
