# BELZONA RESTORED DOCK STEPS GOOD AS NEW AFTER THREE DECADES

ID: 6368

**Customer Location:** Naval dock, La Spezia, Italy  
**Application Date:** June, 1989

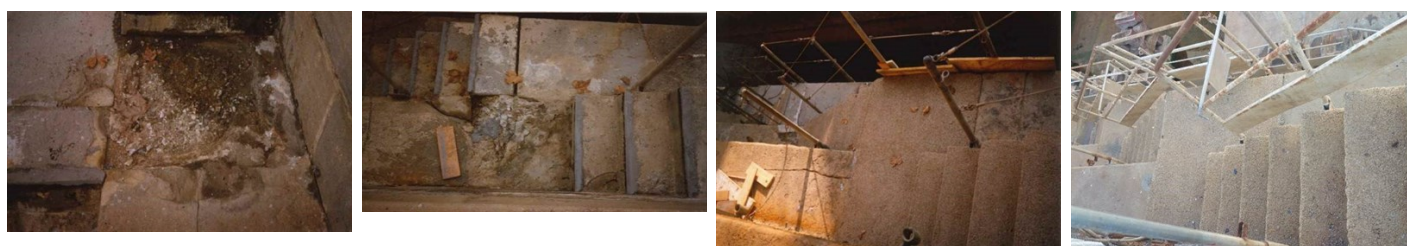
Access steps showed conspicuous signs of deterioration due to the aggressive marine environment and pedestrian traffic from workers over the decades.

\* 1. Deteriorated steps 2. View of the edges during reconstruction 3. Application completed in June 1989 4. View of the same area in September 2016 ,

Application was carried out in accordance with Belzona System Leaflet FPA-1. The damaged area was high-pressure cleaned, manually scarified and rebuilt with Belzona 4111. Belzona 4151 was then applied on top in conjunction with marble chips.

Repair was performed in 1989 and was then inspected in September 2016. After 27 years of service the repaired steps showed no sign of degradation and were in perfect working order.
