# BELZONA PROTECTS NEW BUILT WATER FILTERS

Customer Location: *Desalination Plant, Saudi Arabia*  
Application Date: *August 2016*

*New water debris filters required protection against erosion-corrosion at temperatures up to 130C*

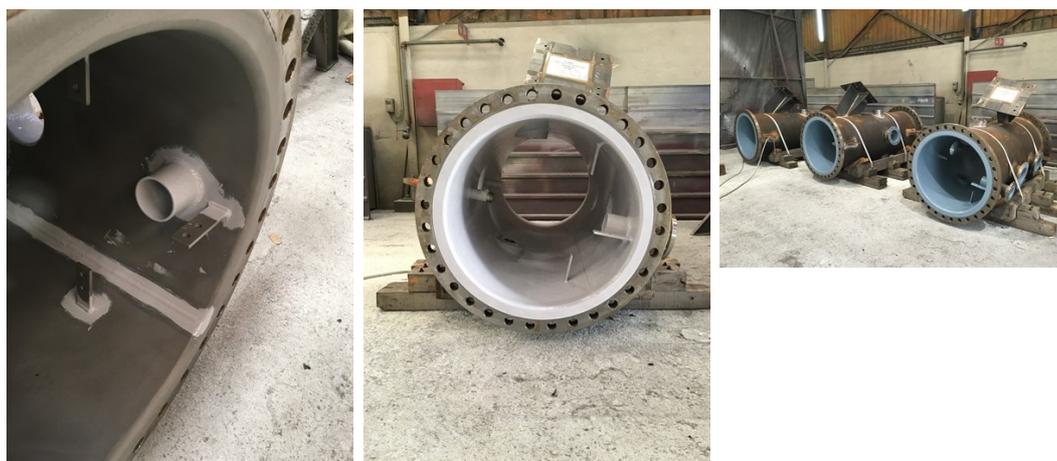
## Photograph Descriptions

- \* 1. Stripe coating with Belzona 1391T ,
- \* 2. First coat of Belzona 1391T applied ,
- \* 3. The three filters fully protected with 2nd coat of Belzona 1391T ,

Internal coating of three water debris filters

The application was carried out in accordance with Belzona Know-How-System Leaflet TCC-5.
