BELZONA COLD PLATE BONDING ELIMINATES TRIP HAZARDS ON OFFSHORE DECK

ID: 6373

Industry: Oil & Gas
Application: FBC-Fans, Blowers and Compressors

Customer Location: Gulf of Mexico, USA
Application Date: September 2016

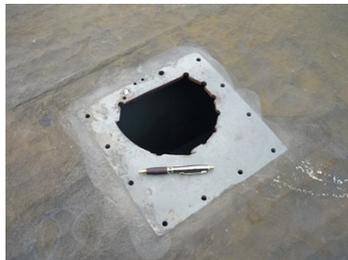
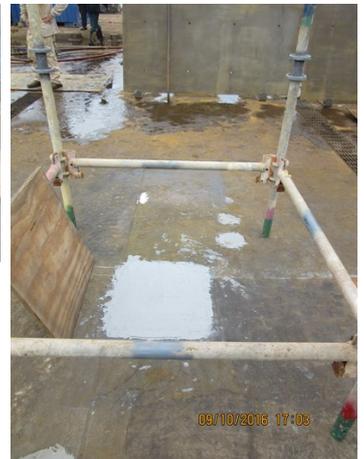
Photograph Descriptions

The Customer changed some equipment on their platform which required piping through an existing deck. Without a nearby penetration, the Customer cut large holes for this temporary equipment and later repaired them with bolted panels. The panels and bolts were raised nearly $\frac{3}{4}$ " above the deck surface creating a trip hazard.

- * 1. Trip hazard plate being removed. ,
- * 2. Surface prepared to near white metal. ,
- * 3. Applying 1121/9341 composite repair. ,
- * 4. Completed Application ,

The application was carried out in accordance with Belzona Know How System Leaflet FBC-6 for sealing leaks and Belzona Cold Plate Bonding.

Belzona 1121 was chosen to repair the deck and not create a raised repair. Due to the hot sun exposure, the deck was 130F during the repairs which further made Belzona 1121 the best choice for the application.
