BELZONA COLD PLATE BONDING ELIMINATES TRIP HAZARDS ON OFFSHORE DECK

ID: 6373

Customer Location: Gulf of Mexico, USA
Application Date: September 2016

Substrate: Steel deck plate
Products: * Belzona 1121 (Super XL-Metal) ,
* Belzona 9341 (Reinforcement Tape) ,

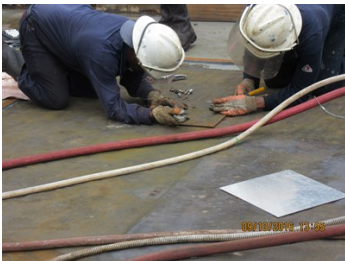
The Customer changed some equipment on their platform which required piping through an existing deck. Without a nearby penetration, the Customer cut large holes for this temporary equipment and later repaired them with bolted panels. The panels and bolts were raised nearly $\frac{3}{4}$ " above the deck surface creating a trip hazard.

- * 1. Trip hazard plate being removed .
- * 2. Surface prepared to near white metal .
- * 3. Applying 1121/9341 composite repair .
- * 4. Completed Application .

Belzona 1121 was chosen to repair the deck and not create a raised repair. Due to the hot sun exposure, the deck was 130F during the repairs which further made Belzona 1121 the best choice for the application.
