# BELZONA COLD PLATE BONDING ELIMINATES TRIP HAZARDS ON OFFSHORE DECK

ID: 6373

Customer Location: Gulf of Mexico, USA  
Application Date: September 2016

Substrate: Steel deck plate  
Products: \* Belzona 1121 (Super XL-Metal) ,  
\* Belzona 9341 (Reinforcement Tape) ,

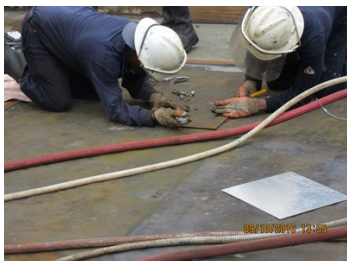
The Customer changed some equipment on their platform which required piping through an existing deck. Without a nearby penetration, the Customer cut large holes for this temporary equipment and later repaired them with bolted panels. The panels and bolts were raised nearly  $\frac{3}{4}$ " above the deck surface creating a trip hazard.

- \* 1. Trip hazard plate being removed . ,
- \* 2. Surface prepared to near white metal. ,
- \* 3. Applying 1121/9341 composite repair. ,
- \* 4. Completed Application ,
