REGULATORY AGENCY ACCEPTS BELZONA SUPERWRAP II

ID: 6376

Industry: Oil & Gas

Customer Location: Gulf of Mexico, USA

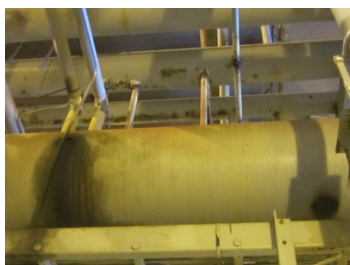
The customer had a section of pipe with external corrosion problems and several through wall defects. Traditional cut and replace alternatives would require costly shutoff of the platform. The entire pipe was welded in place and there were no flanged connections to make a spool swap. An engineered solution was required by the regulatory agency that oversees the platform.

- * 1. Pipe section showing two leaks. ,
- * 2. One of the hole-through defects. ,
- * 3. Super Wrap II is applied to nozzles first. ,
- * 4. Super Wrap II is applied to larger pipe. ,
