REGULATORY AGENCY ACCEPTS BELZONA SUPERWRAP II

Industry: Oil & Gas

Customer Location: Gulf of Mexico, USA

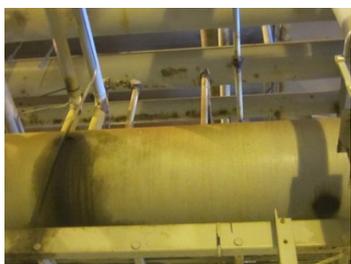
The customer had a section of pipe with external corrosion problems and several through wall defects. Traditional cut and replace alternatives would require costly shutoff of the platform. The entire pipe was welded in place and there were no flanged connections to make a spool swap. An engineered solution was required by the regulatory agency that oversees the platform.

- * 1. Pipe section showing two leaks. ,
- * 2. One of the hole-through defects. ,
- * 3. Super Wrap II is applied to nozzles first. ,
- * 4. Super Wrap II is applied to larger pipe. ,
