# BELZONA SAVES GULF OF MEXICO FROM POTENTIAL OIL SPILLAGE

ID: 6377

Industry: Oil & Gas  
Application: FBC-Fans, Blowers and Compressors

Customer Location: Gulf of Mexico, USA  
Application Date: November 2016

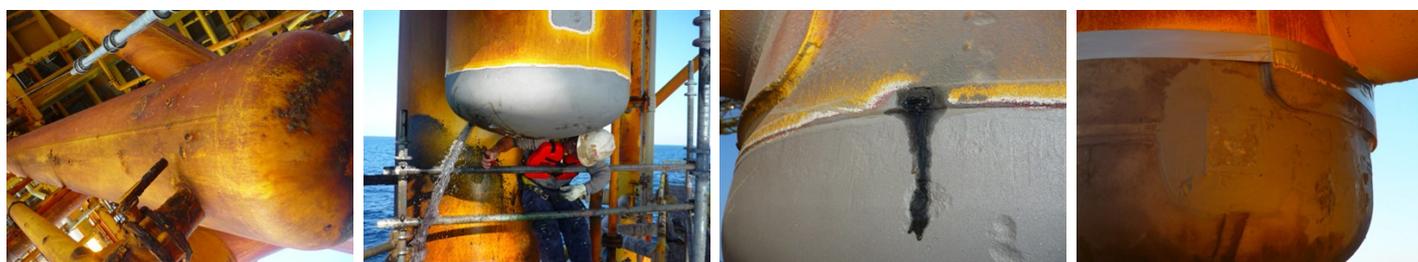
## Photograph Descriptions

All spilled fluids on the offshore platform drain to this lowest point. The sump was a last defense and served as a gravity separator in case any oil is spilled on the platform deck. If there were oil in the bottom of this sump, it would spill into the Gulf of Mexico. Fortunately, there was no oil in the sump as it had been skimmed off prior to blasting operations.

- \* 1. Blistered and corroding sump pile. ,
- \* 2. Through wall defect discovered during blasting operations. ,
- \* 3. Defective area plugged with wood and Belzona 9611 to reduce leak. ,
- \* 4. Cold plate bonding repair with Belzona 1161. ,

The customer had a blasting and painting contractor on board to carry out routine work. While abrasive blasting a sump, a large through wall defect was discovered.

The application was carried out in accordance with Belzona Know How System Leaflet FBC-6 for sealing leaks. First, Belzona 9611 was used to plug over a wooden shim that reduced the leak to a weep. Secondly, Belzona 1161 was used to cold bond a 4"x4" steel plate onto the substrate and seal the leak completely. Belzona 1161 was further used to chamfer around the plate.
