BELZONA® 1391 PROTECTS NEW PIPEWORK

ID: 638

Customer Location: Chemical plant, Cheshire UK
Application Date: August 2003

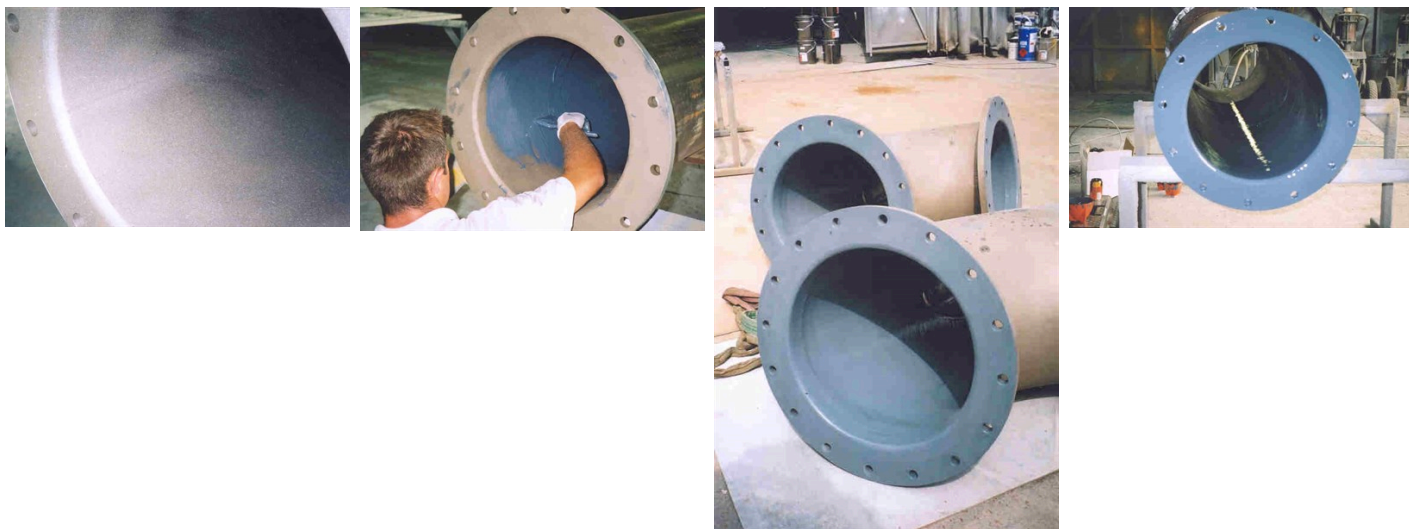
Photograph Descriptions

Moisture in the system creates carbonic acid that corrodes the pipework.

- * The problem ,
- * Application of Belzona® 1391 ,
- * Finished job ,
- * High quality finish clearly visible ,

New gas scrubber pipework

Application was carried out in accordance with Belzona Know-How System Leaflet VPF-2.

The coating of Belzona® 1391 onto the new carbon steel pipework was chosen over traditional cast iron construction as a more cost effective and long term solution. The application continues to perform as expected.
