# BELZONA® 1391 PROTECTS NEW PIPEWORK

Industry: *Chemical & Petrochemical*  
Application: *VPF-Valves, Pipes and Fittings*  
Substrate: *Carbon steel*  
Products: *\* Belzona® 1391 (Ceramic HT Metal) ,*

Customer Location: *Chemical plant, Cheshire UK*  
Application Date: *August 2003*

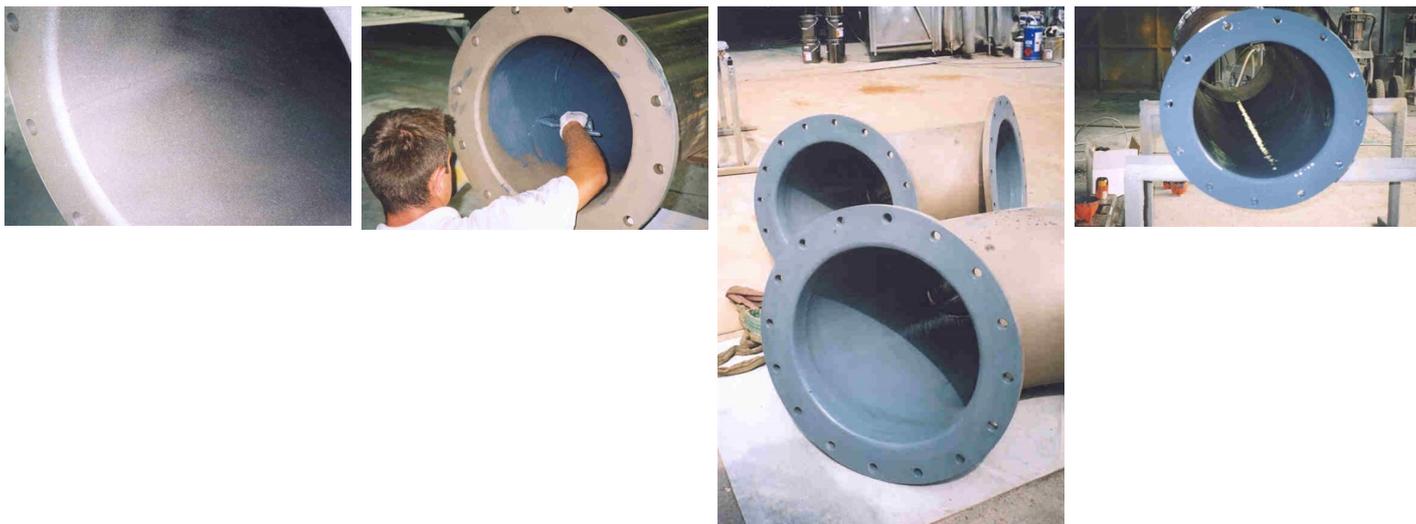
*Moisture in the system creates carbonic acid that corrodes the pipework.*

- \* The problem ,
- \* Application of Belzona® 1391 ,
- \* Finished job ,
- \* High quality finish clearly visible ,

New gas scrubber pipework

Application was carried out in accordance with Belzona Know-How System Leaflet VPF-2.

The coating of Belzona® 1391 onto the new carbon steel pipework was chosen over traditional cast iron construction as a more cost effective and long term solution. The application continues to perform as expected.
