AN OLD STEEL TANK PUT BACK TO SERVICE WITH BELZONA

ID: 6380

Customer Location: Gulf of Mexico, USA
Application Date: August 2016

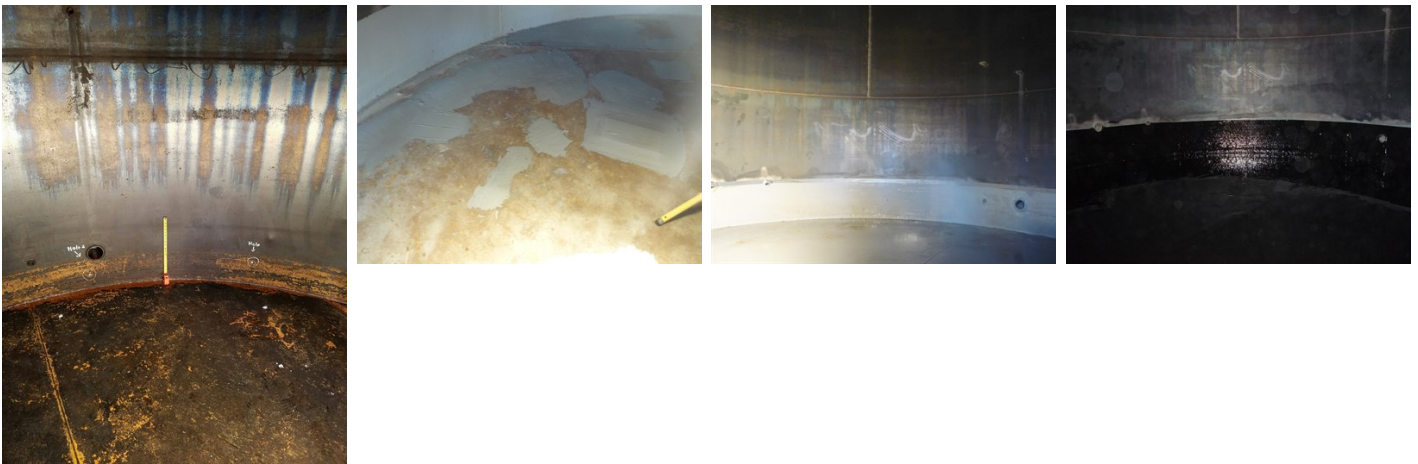
Photograph Descriptions

Hundreds of holes in the floor and 8" up walls of the interior of this bulk storage tank. Large holes were visible and straightforward to repair. Small holes and metal porosity plague the entire surface.

- * 1. Hundreds of holes in tank floor and walls. ,
- * 2. Process of Belzona 1121 composite repair and cold plate bonding on floor. ,
- * 3. First coat Belzona 5811 Grey ,
- * 4. Second coat Belzona 5811 Black ,

Belzona 1121 was used to cold plate bond steel over large holes and incorporated into Belzona 9341 cloth for smaller ones. Two coats of Belzona 5811 was used over all surfaces to seal micro porosity.
