BELZONA SUPERWRAP II REPAIRS DRAIN LINES ON DEEPWATER PLATFORM

ID: 6382

Customer Location: Gulf of Mexico, USA
Application Date: July 2016

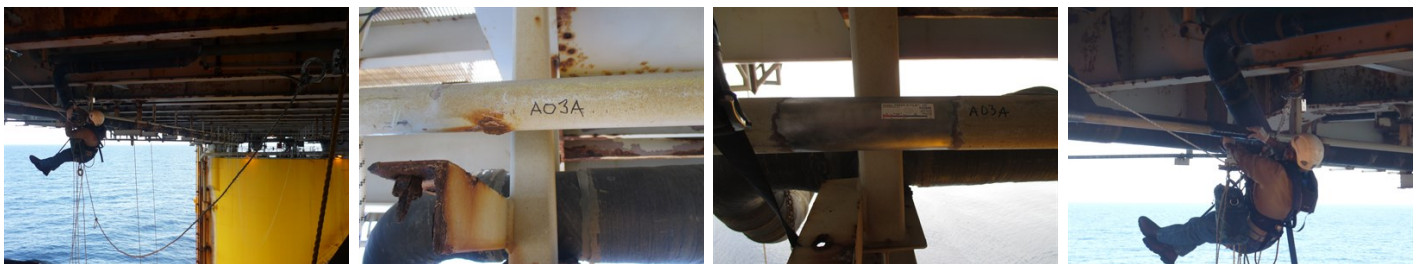
Photograph Descriptions

The drain line goes to the sump, which is the lowest point on the platform. If there is any oil spill or runoff, it could potentially get into the water.

- * 1. Overall view of drain line. ,
- * 2. Example defect on pipe. ,
- * 3. Area prepared and Testex profile tape. ,
- * 4. SuperWrap II installed by rope access. ,

Deepwater platform has 17 areas on drain line that need repair. The repair needed to be ASME compliant.

Being the lowest drain point on the platform, the work had to be carried out by a rope access crew.
