# KEEPING AFLOAT WITH BELZONA

ID: 639

Industry: Oil & Gas  
Application: SOS-Ships and Offshore Structures

Sponson (An air bag or floatation device) attached to a fast rescue craft.

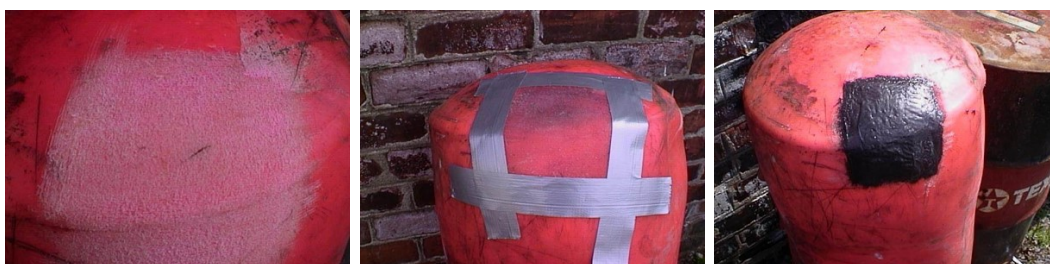
Damaged due to collision with other objects such as boats, flotsam etc.

- \* Surface prepared ,
- \* Area marked up, ready for the Belzona ,
- \* Finished repair ,

Application was carried out in accordance with Belzona Know-How System Leaflet SOS-12.

Every repair with Belzona here saves the purchase of a new sponson at a cost of £400.00. The added bonus was that the repairs could be done at sea allowing the rescue craft to remain in service. This method of repair was used until the craft were taken out of service.
