# WASTEWATER VACUUM TRUCK INTERNAL COATING AND REPAIR

ID: 6393

Customer Location: Los Angeles, CA, USA  
Application Date: Summer of 2015

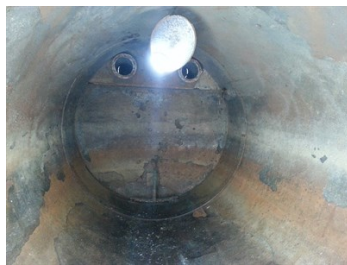
*This damage was leading to failures within the intake pipe and corrosion was being found throughout the tank as a whole. If not addressed properly with the correct protection, the tank would eventually run to failure and require replacement.*

- \* External view of the vacuum truck ,
- \* View of the damaged internal area ,
- \* Belzona 1812 applied to the opening/back opening door ,
- \* Belzona 1321 applied to the intake pipework and Belzona 5811 applied to the entire tank ,

The wastewater and miscellaneous discharges of sewer compatible wastewater (MISC) were causing the interior of the vacuum trucks of the City of Los Angeles to corrode and become damaged from impact abrasion.

The internal area was blasted to white metal and hand applied with two coats of each product to its respective area. Belzona 5811 was applied to protect the entire tank. Belzona 1321 was applied to the intake pipework. Belzona 1812 was then applied for abrasion resistance on the tank opening/back opening doors.
