# WASTEWATER VACUUM TRUCK INTERNAL COATING AND REPAIR

**Industry:** Water / Wastewater  
**Application:** TCC-Tanks and Chemical Containment Areas  
**Substrate:** Steel  
**Products:** \* Belzona 5811 (Immersion Grade) ,  
\* Belzona 1321 (Ceramic S-Metal) ,  
\* Belzona 1812 (Ceramic Carbide FP) ,  
\* ,

**Customer Location:** Los Angeles, CA, USA  
**Application Date:** Summer of 2015

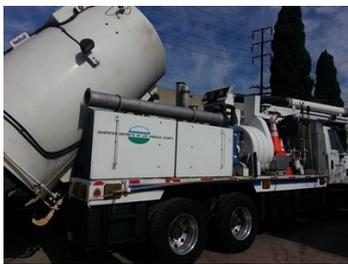
- \* External view of the vacuum truck ,
- \* View of the damaged internal area ,
- \* Belzona 1812 applied to the opening/back opening door ,
- \* Belzona 1321 applied to the intake pipework and Belzona 5811 applied to the entire tank ,

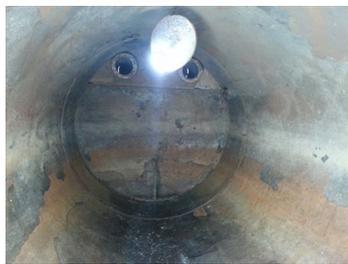
*This damage was leading to failures within the intake pipe and corrosion was being found throughout the tank as a whole. If not addressed properly with the correct protection, the tank would eventually run to failure and require replacement.*

The wastewater and miscellaneous discharges of sewer compatible wastewater (MISC) were causing the interior of the vacuum trucks of the City of Los Angeles to corrode and become damaged from impact abrasion.

The internal area was blasted to white metal and hand applied with two coats of each product to its respective area. Belzona 5811 was applied to protect the entire tank. Belzona 1321 was applied to the intake pipework. Belzona 1812 was then applied for abrasion resistance on the tank opening/back opening doors.
