BELZONA PULVERIZER SHAFT

ID: 64

Industry: *Power*
Application: *MPT-Mechanical Power Transmission*

Customer Location: *Fossil Power Plant in Alabama*
Application Date: *1994*

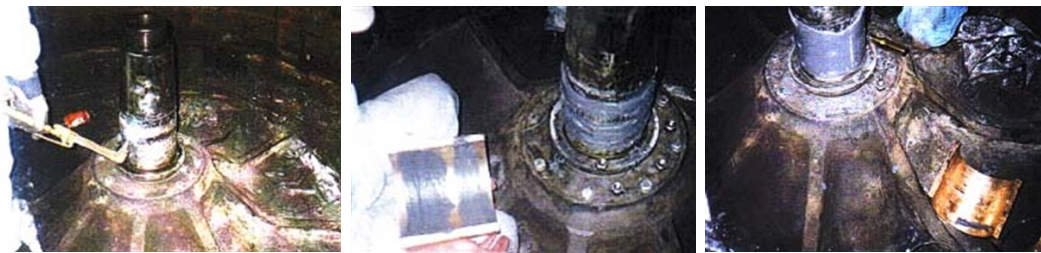
Photograph Descriptions

Coal fines work their way underneath the seal fit and cause wear to the shaft.

- * Sweating oils from the substrate. ,
- * The split-form molding technique is used. ,
- * Formers removed, Belzona® 1311 ready for dressing down. ,

The application was carried out in accordance with Belzona Know-How Leaflet MPT-2.
