# BELZONA PULVERIZER SHAFT

ID: 64

Industry: Power  
Application: MPT-Mechanical Power Transmission

Customer Location: Fossil Power Plant in Alabama  
Application Date: 1994

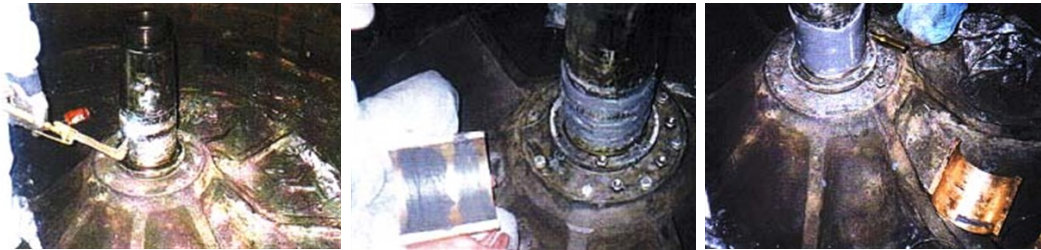
## Photograph Descriptions

Coal fines work their way underneath the seal fit and cause wear to the shaft.

- \* Sweating oils from the substrate. ,
- \* The split-form molding technique is used. ,
- \* Formers removed, Belzona® 1311 ready for dressing down. ,

The application was carried out in accordance with Belzona Know-How Leaflet MPT-2.

Since 1994, several shafts have been done. Less than \$400 in Belzona product saved the plant one week of downtime.
