BELZONA HELPS FIRE PUMP PERFORM AGAIN

ID: 6403

Bronze Fire pump impeller on a US Navy Ship

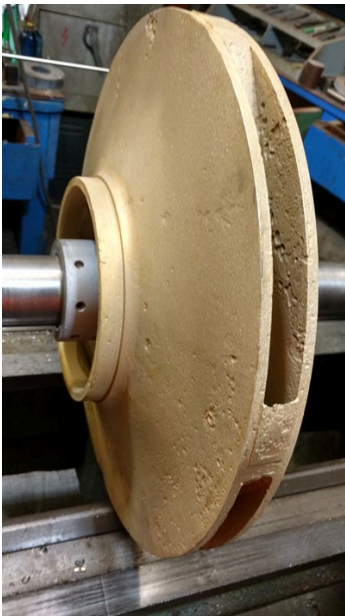
Impeller had suffered heavy cavitation and erosion due to contact with salt water.

- * 1. Bronze pump impeller grit blasted and showing damage. ,
- * 2. Eroded areas rebuilt with Belzona 1111 ,
- * 3. Impeller coated with Belzona 1341 ,
- * 4. Belzona 1131 applied to wear ring area ,

The application was carried out in accordance with a modified version of Belzona System Leaflet CEP-3. Cavitated and eroded areas were rebuilt with Belzona 1111. The impeller was then coated with two coats of Belzona 1341 by brush; grey base coat, followed

by a blue top coat. Critical wear ring area was rebuilt with Belzona 1131.
