# BELZONA REPAIRS AND PROTECTS LEAKING TRANSFORMER TURRETS

ID: 6406

Customer Location: National Grid, Scotland, UK  
Application Date: October 2015

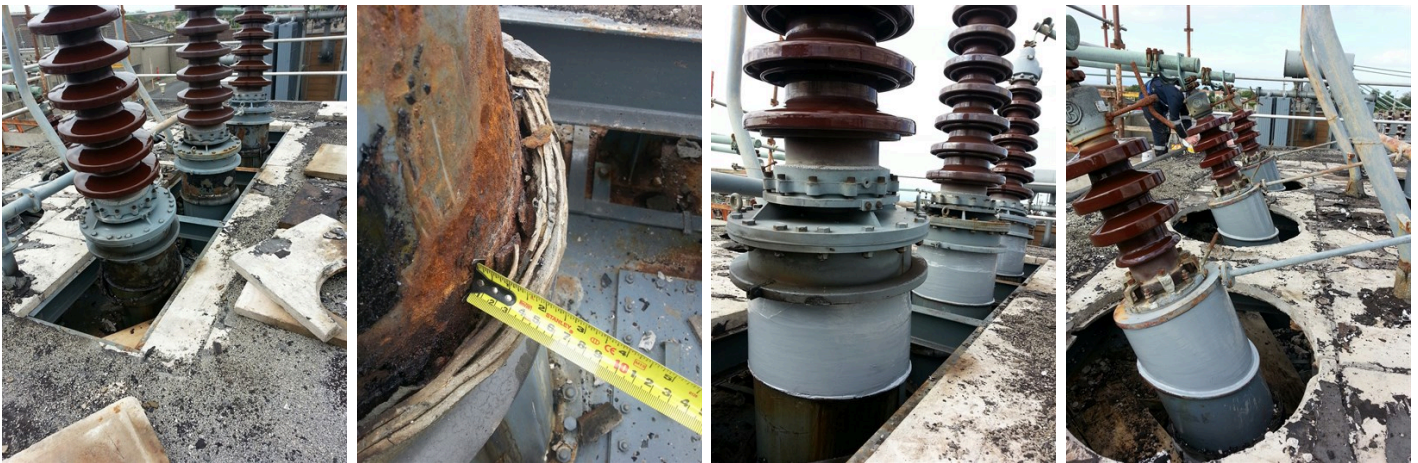
The corrosion had led to a loss of wall thickness. Some of these thinned areas had begun to leak. Loss of oil from the transformer represented a safety & environmental hazard. A fast, long term repair was required to fix the problem. No hot works are allowed due to the presence of oil.

\* 1. Turrets before work commenced 2. Close up of the corrosion on the turrets 3. Plates bonded in place with Belzona 1161 4. Belzona 5831 applied to provide long term corrosion protection ,

Transformer turrets are normally sealed from the weather into the roof above the transformer. Rainwater had leaked in between the roof & the turret allowing corrosion to take place.

Application was carried out in accordance with modified versions of Belzona System Leaflets TCC-1 and TCC-5. The corrosion was removed & a surface profile created with MBX Bristle Blaster. Belzona 1161 was then used to bond doubler plates to the surface. These plates were fabricated so that two sections fitted around the circumference of the turret. The repaired areas were then over coated with Belzona 5831 for further corrosion resistance.
