Belzona Makes Quick Work of Cleat Repair

Application: SHM-Solids Handling Machinery

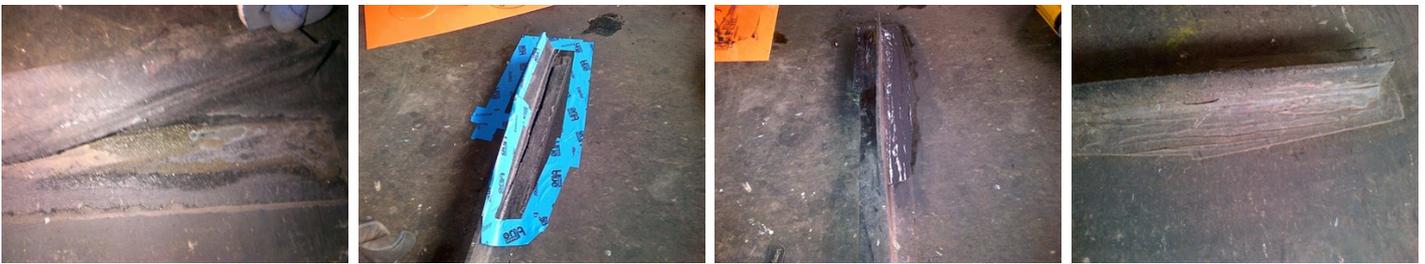
Photograph Descriptions

Cleat on conveyor belt used to sort materials at a recycling facility was torn and ineffective. The design of the equipment was allowing the conveyor to become clogged and putting more strain on the cleats than the original vulcanization could handle.

* 1. Damaged cleat
2. Repair area cleaned, roughened, and conditioned
3. Repair completed
4. Repair revisited 8 months later, still performing perfectly ,

The application was carried out in accordance with modified versions of SHM-1 and SHM-5. The area was cleaned and roughened using the Belzona Roughing (Carding) brush to create a woolly finish. Belzona 2911 was used to condition the surface and the edges were taped to keep the repair within the conditioned area. Belzona 2311 was used to bond the cleat back to the belt and used to repair and flash over the torn areas of the cleat.

A new belt would have cost the customer thousands of dollars. Hot vulcanization would have cost hundreds of dollars and hour in labor and downtime and most likely not been a permanent solution. The Belzona solution cost less than \$75 and was performed at the end of the day so there was no downtime as a result. After nine months the repair is in perfect condition and the customer has
