# Belzona Solution for Tricky Pipe Penetration

ID: 6410

**Customer Location:** Tennessee, USA  
**Application Date:** September 2016

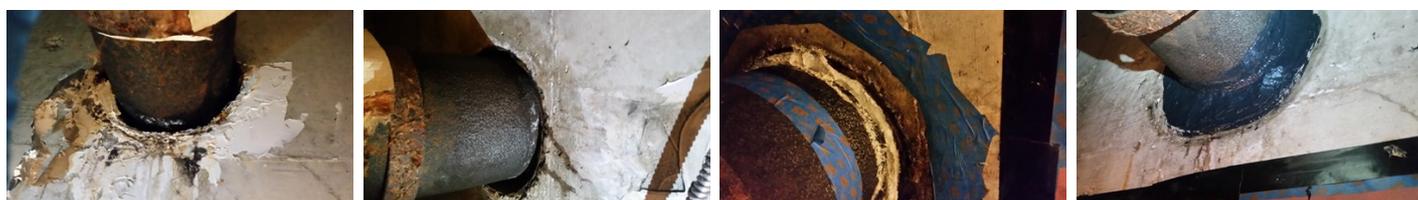
## Photograph Descriptions

The pipe penetration is in a basement wall above the suspended ceiling. The exterior of the wall is under 10 feet of earth and concrete so the customer needed a way to solve the leak from the inside of the wall. They also needed a solution that would work with multiple substrates.

\* 1) Leaking pipe penetration with remnants of previous repair attempts using caulk and plaster 2) Pipe and concrete cleaned and ready for conditioning 3) Conditioned area ready for application of Belzona 2211, a foam filler was used as a backer in the area between the wall and the pipe 4) Application complete with a flexible two layer "boot" that is seamlessly adhered to the pipe and wall ,

Pipe penetration was allowing rain water to leak through the wall into workspaces at a local hospital.

Application was carried out using knowledge gained from Belzona System Leaflets GSS-3 and RPA-8. Application area was cleaned using a bristle blaster and concrete grinding disc. A foam filler was applied between the pipe and the wall to act as a backer during the application. Area was conditioned with Belzona 2911 and edges were taped to keep the application within the conditioned area. Belzona 2211 with embedded Belzona 9341 was applied as the first layer and tape was removed. Approximately 90 minutes later the edges were re-taped and a second layer of Belzona 2211 was applied to complete the repair.

Previous attempts to stop the leak had not worked. They needed a permanent solution that would allow for movement between the pipe and wall and bond to both. Belzona 100% solids material were a perfect solution. Belzona 2211 has excellent adhesion to many substrates and maintains its flexible properties after cure, allowing for a flexible "boot" that is firmly adhered in a seamless
