# Belzona 1212 Stops a Live Leak in a Cooling Tower Pan

Customer Location: Manufacturing Facility, Tennessee, USA  
Application Date: October 2016

Substrate: Galvanized steel  
Products: \* Belzona 1212 ,  
\* Belzona 9611 ,

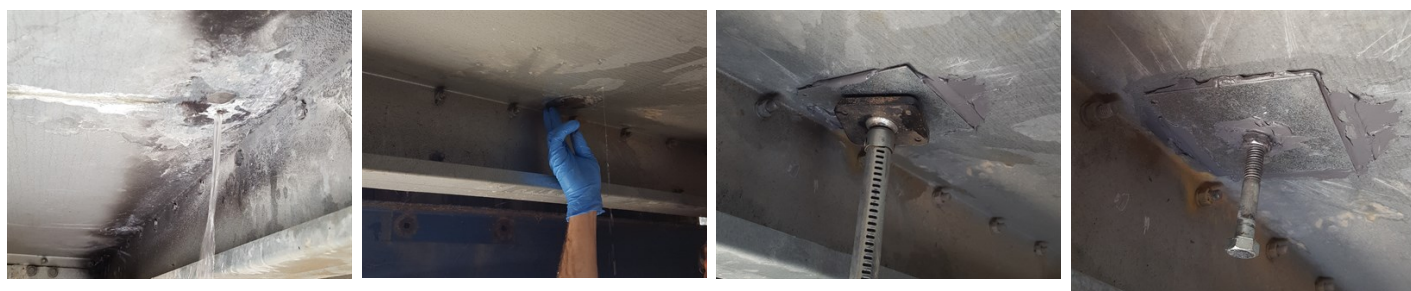
Several live leaks in a cooling tower pan were leaking water at a rate of several gallons per hour. The Customer needed a way to stop the leaks without shutting the tower down and interrupting their manufacturing process.

- \* Leak with evidence of previous repair attempts visible. ,
- \* Stemming the leak with Belzona 9611. ,
- \* Plate pressed into place with Belzona 1212 and a hydraulic jack. ,
- \* Cold bonded repair complete with a final bolt in place. ,

The application was carried out in accordance with a modified version of Belzona Know-How System Leaflet TCC-1. A plate was had been fabricated with a hole in the middle to allow water to run out and a 1/2" nut was inserted into the plate using Belzona 1212. The repair area was prepared using hand tools and a mechanical grinder and the leak was partially stemmed using Belzona 9611. The prepared area and the plate were then wet out with enough Belzona 1212 to create a good bond and the plate was pressed into place and held using a hydraulic jack. Water was allowed to run through the hole in the nut while the plate cured in place for approximately 60 minutes. The jack and support bar were then removed. A small amount of Belzona 1212 was added to the threads of a 1/2" bolt and it was screwed into place to stop the leak and finalize the repair.
