Belzona 1212 Repairs Live Transformer Oil Leak

ID: 6412

Customer Location: Chemical Plant, Tennessee, USA
Application Date: January 2016

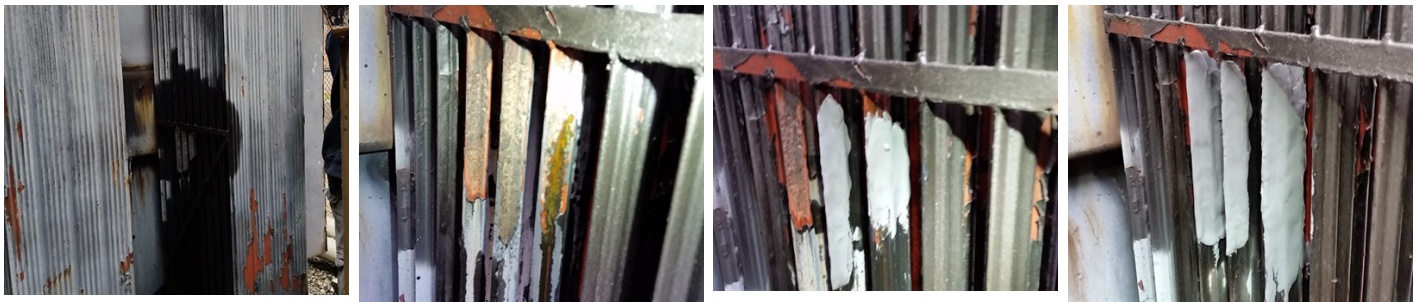
Photograph Descriptions

Transformer cooling fin was dripping oil onto the ground creating an environmental hazard. Customer needed a way to stop the leak without draining the transformer and welding it which would have required at least a whole day of downtime for the entire plant.

- * Transformer leaking. ,
- * Old coating and paint removed to expose the leak. ,
- * Application in process (note small bubble where the pressure was pushing through, this was resolved as the 1212 started to solidify). ,
- * The leak stopped and two additional corroded areas reinforced to prevent future leaks ,

The application was carried out in accordance with Belzona Know-how System Leaflet TCC-1. Peeling paint was removed and other corrosion was removed using a wire brush and an emery cloth. Belzona 1212 was applied in a thin coat and continually pressed back into place as the oil pressure pushed through. Due to the cold temperatures (slightly above 40 F) it took approximately two hours to complete the repair but as Belzona 1212 solidified the leak was slowed and stopped. A second layer of Belzona 1212 was applied where the leak had been. Two other areas where leaks could soon develop were coated with a thick layer of Belzona 1212 too as a preventative measure.

Shutting down the plant to drain the transformer and weld was not an option and even if that was possible, would have been far more expensive than the Belzona repair. The Belzona solution allowed the plant to continue operating while stopping the leak at a cost of less than \$145. After nearly a year of service the customer recently reported that the repair has held up perfectly.
