# Belzona Slows Abrasion to a Crawl

ID: 6414

Industry: General Industry  
Application: SHM-Solids Handling Machinery

Customer Location: Middle Tennessee Manufacturer  
Application Date: June 2016

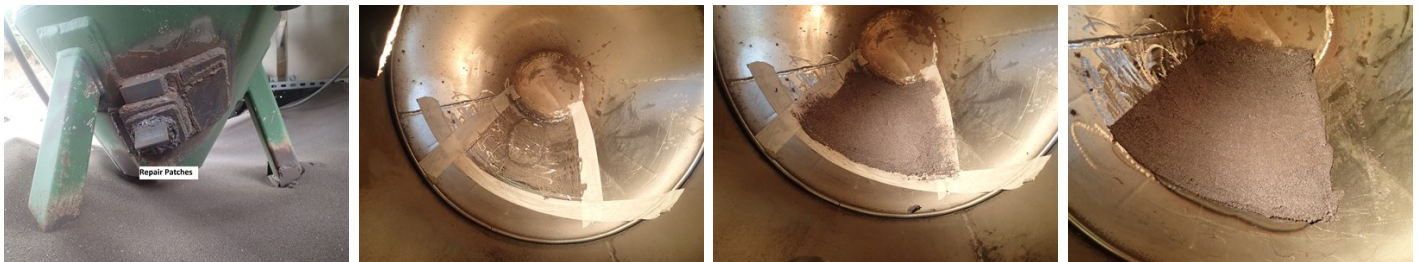
## Photograph Descriptions

Customer uses pneumatic conveying system to move sand throughout their large facility, this blast pot was being repaired constantly as pressurized air combined with the sand in system to abrade holes in the pot opposite port into which air was injected. New equipment was only lasting a few weeks before needing to be patched and after than needed constant repair.

- \* 1) Blast pot with patch on top of patch, the previous solution ,
- \* 2) Impact area inside pot prepped for application ,
- \* 3) Application of Belzona 1812 in progress ,
- \* 4) Application Complete ,

Blast pot used in the customers pneumatic conveyor system was being worn through.

Application was carried out using a modified version of Belzona System Leaflet SHM-11. Application area was roughened using a grinder and grooved using a die grinder. Rebate grooves were cut in at the edge of the application area. Final cleaning was done using Belzona 9111. The edges were taped in order to keep the Belzona material within the prepared area. Belzona 1812 was then applied, taking care to push it well into the roughened area before building it up too thickly. Final thickness was approximately 1/4 inch.

The OEM equipment was not lasting for more than a few weeks in the environment the constant blowouts were creating unscheduled shut downs and lost productivity. The Belzona application has been in place for 6 months and is still performing well
