# Belzona Expansion Joints a Better Solution

**Industry:** Buildings & Structures  
**Application:** FPA-Floor Problem Areas  
**Substrate:** Brick  
**Products:** \* Belzona 2211 (MP Hi-Build Elastomer) ,  
\* Belzona 2911 (Elastomer QD Conditioner) ,

**Customer Location:** Nashville Tennessee Convention Center  
**Application Date:** March 2016

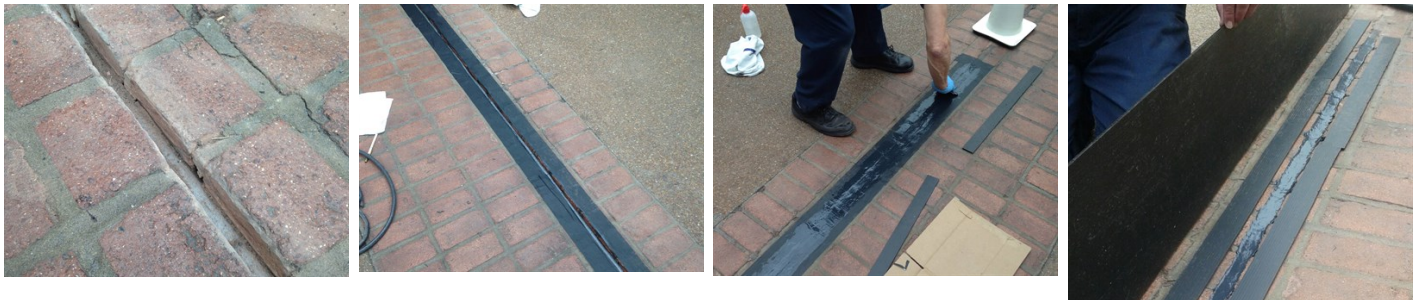
## Photograph Descriptions

\* 1) Joint edges ground and cleaned to remove old adhesives and loose material 2) Joint edges taped and conditioned 3) Application in process 4) Application completed ,

Application was carried out in accordance with Belzona System Leaflet FPA-6. Old caulk and filler material was removed and the joint edges were ground with a masonry disc to insure a bond to firm substrate. Loose material was cleaned away and a solvent wipe was used to remove dust. The edges of the joint were taped with gaffers tape to insure materials did not extend beyond the intended area of application. Backer rod was inserted into the gap and set at depth of 1/4". Belzona 2911 was used to condition the edges of the expansion joint. After allowing the Belzona 2911 to dry, Belzona 2211 was troweled into the joint, taking care to insure good contact at the edges of the joint. The joint was then allowed to cure before foot traffic was allowed to return to the surface. The joint application was split into two parts to allow pedestrian traffic to use one lane of the bridge during cure.
