# BELZONA SAVES NEW WIND TURBINE

ID: 6416

Customer Location: Windfarm, Croatia  
Application Date: August 2011

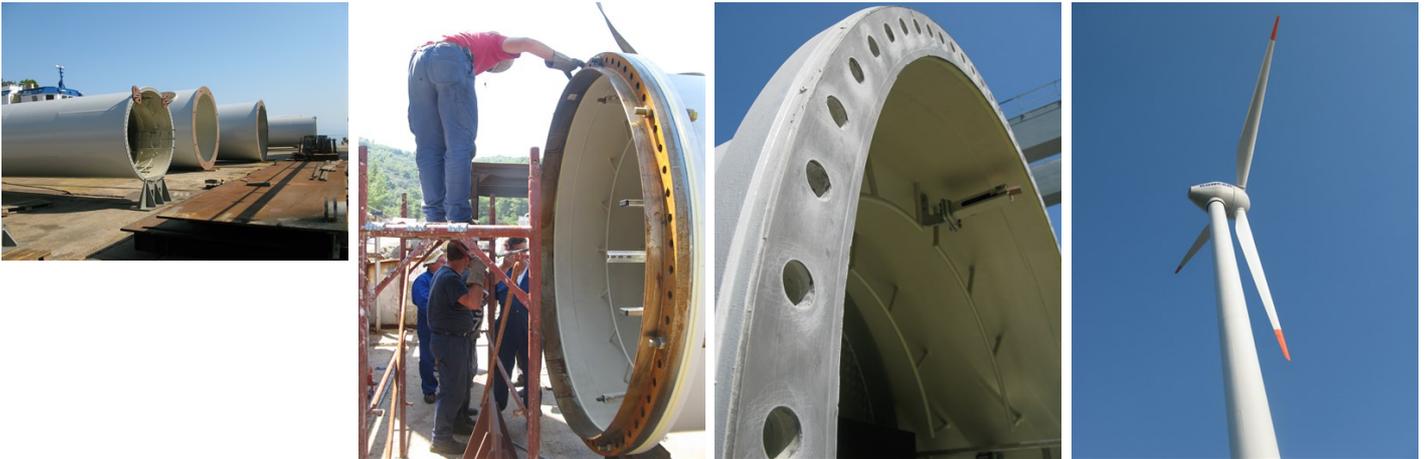
## Photograph Descriptions

Flange section of one of the windmills was found to be distorted and needed to be rebuilt to ensure good fit to the other section.

\* 1. Section that needed to be rebuilt 2. Former in place 3. Section rebuilt 4. Windmill installed ,

The application was carried out in accordance with a modified Belzona Know-How System Leaflet GSS-7. A former was used to guide the rebuilding of the flange face.
