BELZONA IMPROVES SAFETY WITH GRIP SYSTEM

Application: FPA-Floor Problem Areas

Customer Location: Factory, Kirkop, Malta.

Application Date: May 2013

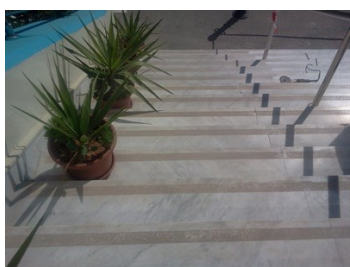
Marble stairs were very slippery, especially in wet conditions.

- * 1. Abraded nosing resulted in a non-effective solution ,
- * 2. Nosing ground by carbide discs ,
- * 3. Area Masked off ,
- * 4. Completed application ,

The previous solutions of abrading the nose or stick on strips had proved to be ineffective. Belzona 4411 reduced the potential for accidents as well as creating an aesthetically pleasing finish.
