BELZONA IMPROVES SAFETY WITH GRIP SYSTEM

ID: 6418

Application: FPA-Floor Problem Areas

Customer Location: Factory, Kirkop, Malta.

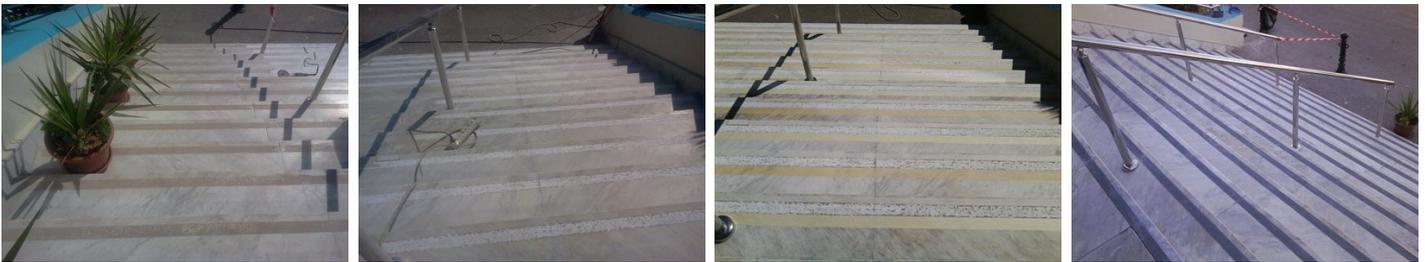
Photograph Descriptions

Marble stairs were very slippery, especially in wet conditions.

- * 1. Abraded nosing resulted in a non-effective solution ,
- * 2. Nosing ground by carbide discs ,
- * 3. Area Masked off ,
- * 4. Completed application ,

The application was carried out in accordance with Belzona Know-How System Leaflet FPA-8. The steps were marked and the nosing ground with carbide discs. After masking off all the steps, Belzona 4411 was brushed on and sprinkled with Belzona 9221.

The previous solutions of abrading the nose or stick on strips had proved to be ineffective. Belzona 4411 reduced the potential for accidents as well as creating an aesthetically pleasing finish.
