# BELZONA RENEWS 40 METRE VERTICAL EXPANSION JOINT

**Industry:** Buildings & Structures  
**Application:** WPA-Wall Problem Areas  
**Substrate:** Concrete  
**Products:** \* Belzona 4141 (Magma-Build). ,  
\* Belzona 2211 (MP Hi-Build elastomer). ,  
\* Belzona 3111 (Flexible Membrane). ,

**Customer Location:** Industrial unit, Malta  
**Application Date:** August 2014.

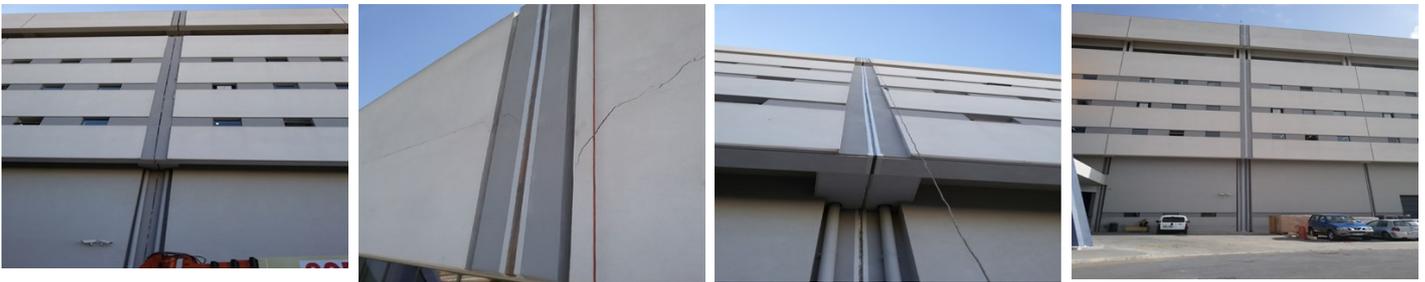
The existing joint material had failed resulting in a route for water ingress inside the building. Some of the offices could not be used because of this leak.

<div>  
<table cellpadding="0" cellspacing="0" align="left">  
<tbody>  
<tr>  
<td style="padding-top: 0cm; padding-right: 9.0pt; padding-bottom: 0cm; padding-left: 9.0pt;" align="left" valign="top">  
<p class="MsoNormalCxSpFirst" style="background-image: initial; background-position: initial; background-size: initial; background-repeat: initial; background-attachment: initial; background-origin: initial; background-clip: initial;"><span style="font-size: 11.5pt; line-height: 107%; font-family: "Helvetica",sans-serif; mso-fareast-font-family: "Times New Roman";">1. </span><span style="font-size: 11.5pt; line-height: 107%; font-family: Helvetica, sans-serif; background-image: initial; background-position: initial; background-size: initial; background-repeat: initial; background-attachment: initial; background-origin: initial; background-clip: initial;">Existing joint material removed and cleaned.</span> ,  
<p class="MsoNormalCxSpMiddle" style="background-image: initial; background-position: initial; background-size: initial; background-repeat: initial; background-attachment: initial; background-origin: initial; background-clip: initial;"><span style="font-size: 11.5pt; line-height: 107%; font-family: "Helvetica",sans-serif; mso-fareast-font-family: "Times New Roman";">2. Masking and conditioned. </span> ,  
<p class="MsoNormalCxSpMiddle" style="background-image: initial; background-position: initial; background-size: initial; background-repeat: initial; background-attachment: initial; background-origin: initial; background-clip: initial;"><span style="font-size: 11.5pt; line-height: 107%; font-family: "Helvetica",sans-serif; mso-fareast-font-family: "Times New Roman";">3. Application of Belzona 2211 Elastomer. </span> ,  
<p class="MsoNormalCxSpMiddle" style="background-image: initial; background-position: initial; background-size: initial; background-repeat: initial; background-attachment: initial; background-origin: initial; background-clip: initial;">
For more examples of Belzona Know - How In Action, please visit <https://khia.belzona.com>
ISO 9001:2015  
FS 695214  
ISO 14001:2015  
EMS 695213
Belzona products are  
manufactured under an ISO  
9000 Registered Quality  
Management System.
[www.belzona.com](http://www.belzona.com)

**BELZONA**<sup>®</sup>  
Repair • Protect • Improve
background-repeat: initial; background-attachment: initial; background-origin: initial; background-clip: initial;"><span style="font-size: 11.5pt; line-height: 107%; font-family: &quot;Helvetica&quot;;sans-serif; mso-fareast-font-family: &quot;Times New Roman&quot;;">4. Completed application.</span> ,  
</td>  
</tr>  
</tbody>  
</table>  
</div>

The application was carried out in accordance with Belzona Know-How System Leaflet WPA-3 and WPA-9. The existing joint material was removed and the edges were rebuilt with Belzona 4141. Belzona 2211 was applied to seal the joint. To further seal and encapsulate the joint, bridging tape was applied over the expansion joint prior to the application of the Belzona 3111 system. This also provided an aesthetically pleasing finish.
