BELZONA RESTORES AND PROTECTS GATE VALVE

ID: 6421

Customer Location: Copper Mining Company, Bulgaria
Application Date: April, 2015

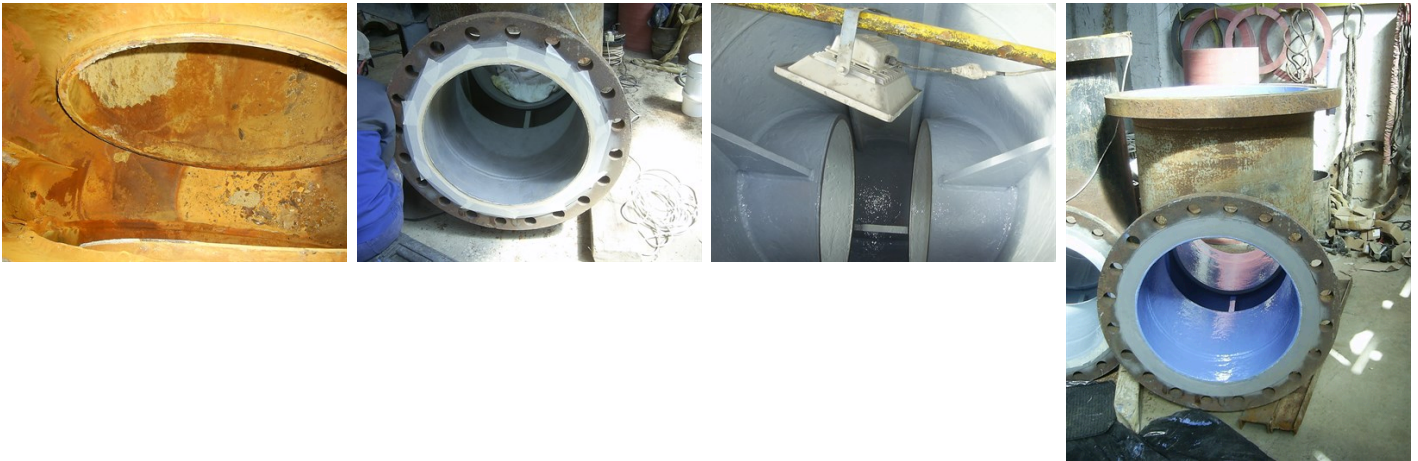
Photograph Descriptions

Strong corrosion and erosion on the inner surfaces of all 3 gate valves.

- * 1. General view of the valve before repair ,
- * 2. After blasting and flange masking ,
- * 3. 1st coat of Supermetalglide applied ,
- * 4. Final view of the completed application ,

The application was carried out according to Belzona Know-How System Leaflet CEP-1 and CEP-3. The internal welds, pitting and damage were filled with Belzona 1311 then two coats of Belzona 1341 were applied.
