BELZONA CORROSION PROTECTION FOR CO2 ABSORBER TOWER

ID: 6424

Customer Location: Nitrogen Fertilizer Plant, Bulgaria
Application Date: August 2014

60 metre tall process CO2 absorber tower required corrosion protection

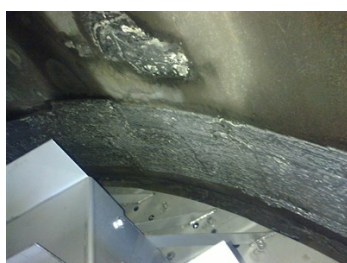
Significant defects of the inner walls and the bottom of the absorber due to corrosion and erosion in the presence of aggressive chemicals such as MDEA & MEA at elevated temperatures (80-100°C).

- * 1. Inspection in 2016 of the lining applied in 2014 ,
- * 2. View of the pad welded defect areas ,
- * 3. View of repair with Belzona 1311 ,
- * 4. The final application with Belzona 1391 ,

The applications were carried out in accordance with Belzona Know-How Leaflet TCC-3. The customer pad welded deeply pitted areas. Less damaged areas were filled and smoothed with Belzona 1311 before coating with Belzona 1391.
