GASSIFIER MIXER BLADES PROTECTED WITH BELZONA

ID: 643

Customer Location: Refinery El Dorado, Kansas
Application Date: April 2004

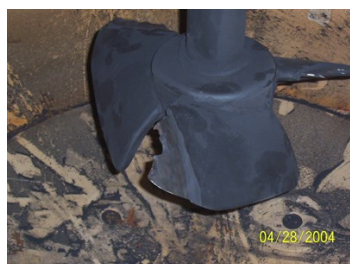
The original rubber coating failed. The leading edge of the steel wore away and large chunks of steel were missing. This decreased the efficiency of the unit.

- * Damaged Gasifier mixer blade leading edge missing ,
- * New leading edge welded and rubber being prepared ,
- * Application of Belzona® 2121 ,
- * Finished application ,
