# EASY LINTEL REPAIR WITH BELZONA

ID: 6435

**Industry:** Buildings & Structures  
**Application:** WPA-Wall Problem Areas  
**Substrate:** Concrete and Steel  
**Products:** \* Belzona® 4141 Belzona® 4911 ,

**Customer Location:** Housing Association, Cleveland, UK  
**Application Date:** 2017

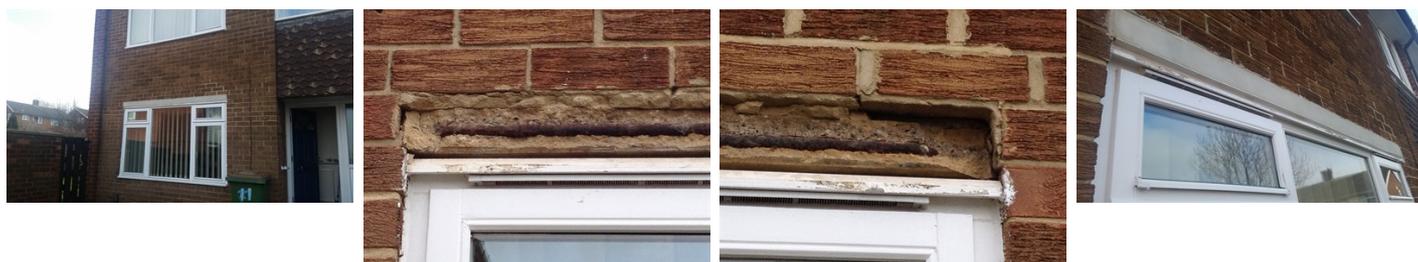
The entire front face of the concrete "Boot" lintel had failed due to re-bar corrosion. The customer wanted a long-term solution without having the need to disturb the structure.

- \* 1. Overview (after repair) ,
- \* 2 & 3. Damaged Lintel ,
- \* 4. Completed repair ,

Application carried out in accordance with Belzona system leaflet WPA-4

The application was completed in just 2 hours. Conventional replacement would have been costly, time consuming and disruptive. The customer has used Belzona 4141 before and is very happy with the results.
