BELZONA SECURES TOWER BLOCK

ID: 6436

Industry: Buildings & Structures
Application: WPA-Wall Problem Areas
Substrate: Concrete and Steel
Products: * Belzona® 4141 (Magma Build) ,
* Belzona® 5151 (Hi-Build Cladding) ,

Customer Location: Housing Association, Cleveland, UK
Application Date: 2016

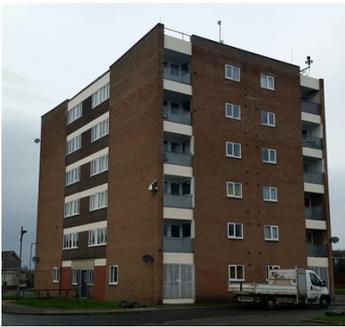
Carbonation of the concrete had caused severe spalling threatening the structure of the balconies and creating a risk of falling debris.

- * 1. Overview of completed work. ,
- * 2. Typical damage. ,
- * 3. Belzona 4141 Application in progress. ,
- * 4. Panel completed after coating with Belzona 5151 ,

Application carried out in accordance with Belzona system leaflet WPA-4 for the concrete repairs and WPA-1 for the Belzona 5151 anti-carbonation coating.
