# BELZONA SECURES TOWER BLOCK

ID: 6436

Application: WPA-Wall Problem Areas

Customer Location: Housing Association, Cleveland, UK

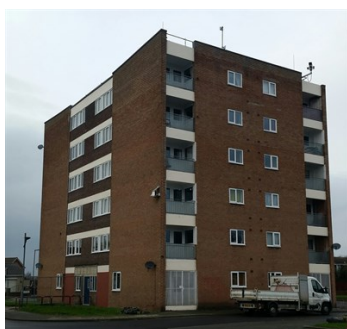
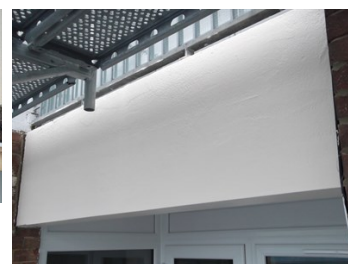
Carbonation of the concrete had caused severe spalling threatening the structure of the balconies and creating a risk of falling debris.

- \* 1. Overview of completed work. ,
- \* 2. Typical damage. ,
- \* 3. Belzona 4141 Application in progress. ,
- \* 4. Panel completed after coating with Belzona 5151 ,

Application carried out in accordance with Belzona system leaflet WPA-4 for the concrete repairs and WPA-1 for the Belzona 5151 anti-carbonation coating.
