# BELZONA RECLAIMS DAMAGED BOWLING ALLEY SIDEPLATE

ID: 645

**Customer Location:** Bowling Centre, Calgary, Alberta, Canada  
**Application Date:** November 2005

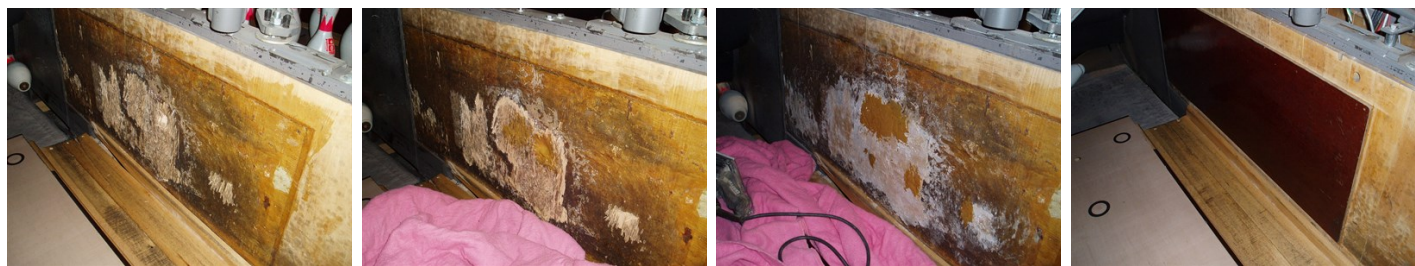
**Photograph Descriptions**

*This damage if not repaired would damage customer bowling balls and lead to loss of sanctioning and income.*

- \* Damaged hardwood slab, 3/4-inch deep ,
- \* First layer of Belzona® 8111 applied ,
- \* Final layer of Belzona® 8111 after sanding ,
- \* Kick plate reinstalled over damaged area ,

Damaged side plate on the pin deck

The method used was similar to rebuilding pitting corrosion on vertical vessel walls, a modified Belzona Know-How System Leaflet TCC-5.

The customer had tried other non-traditional methods such as body filler and drywall mud all unsuccessful.
