Belzona Lines New Build Desalter with Belzona 1391T

ID: 6454

Industry: Oil & Gas
Application: TCC-Tanks and Chemical Containment Areas
Substrate: Carbon Steel
Products: * Belzona 1391T ,

Customer Location: Iraq
Application Date: January 2017

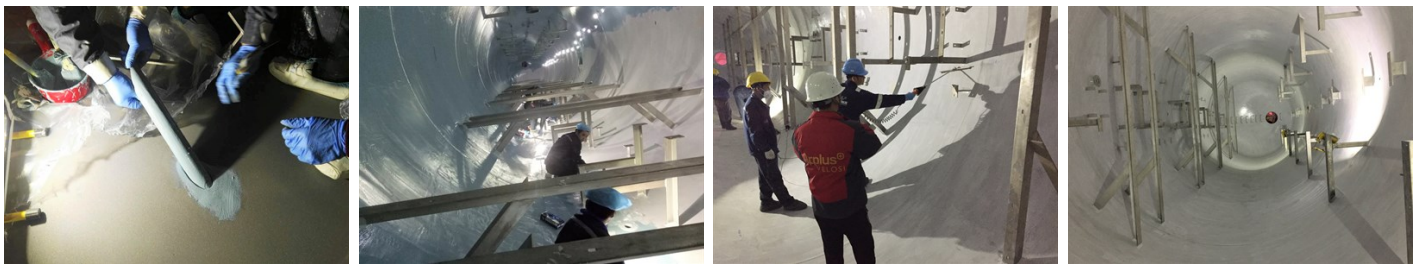
Photograph Descriptions

Newly fabricated vessel which was required to have an internal protective coating.

- * 1.Nozzle Insert ,
- * 2.2nd Coating ,
- * 3.Spark Test ,
- * 4.Final ,

Operating Temperature Min/Norm/Max:20/58/70 , Service /Crude Oil + Water + Sour Gas and specified with Belzona internal lining and nozzle insert.

Application was carried out in accordance with Belzona Know-How System Leaflet TCC-5 and TCC-16b . Preformed nozzle inserts were created and bonded into small diameter nozzles to ensure continuity of protection.
